Devil's Slide/Hwy 1 Storm Repair

Daily Updates from Bijan Sartipi

Daily Update
July 6

Devil's Slide (post mile 39.14)

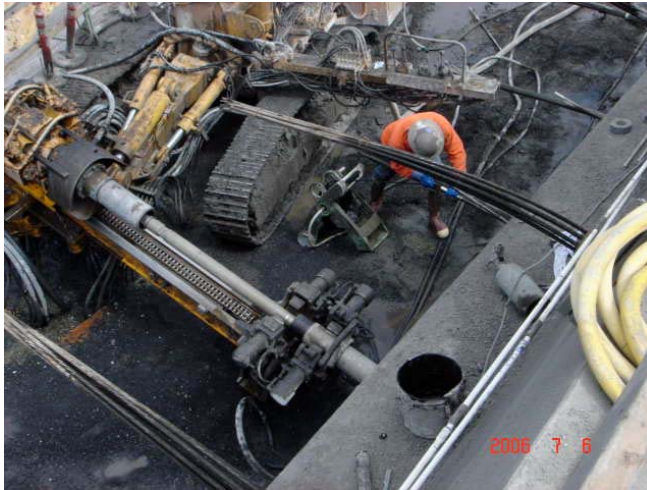
- See 7/5/06 Update for complete summary.
- Level 'B' (lower level ocean side) – Drilling for tie backs continued using two rigs. 40 of 58 tie backs now installed.

Drilling at level B

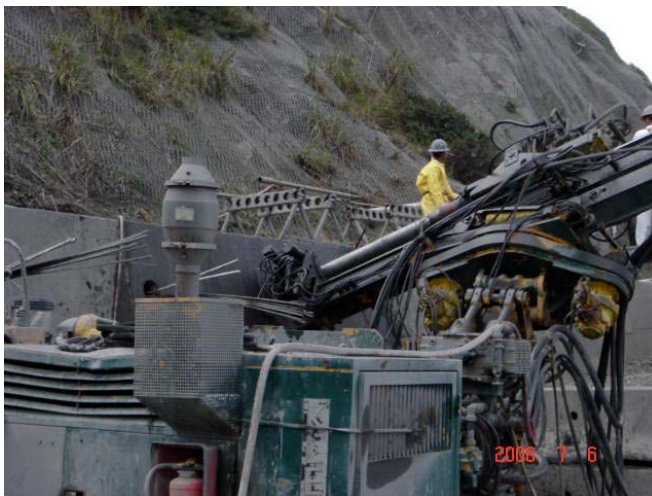
- Level 'D' (upper level cliff side) – Drilling for tie backs continued. 9 of 33 now installed.

Drilling at level D

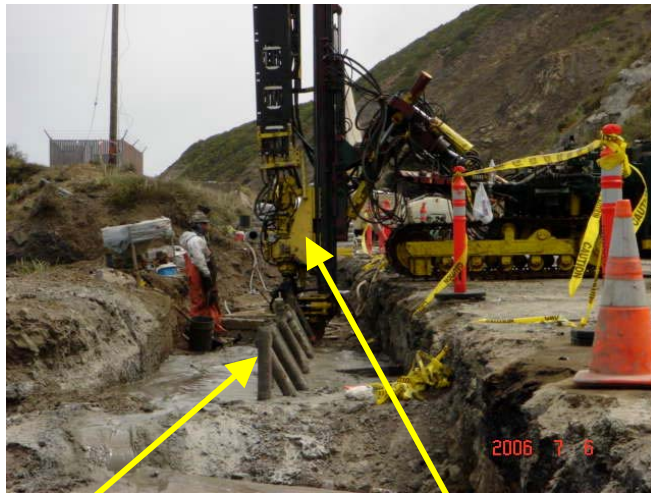
- Drilling and driving steel piles continued today. The 4 inch diameter steel piles are filled with cement slurry after being driven into the ground.

Steel piles

Drill rig

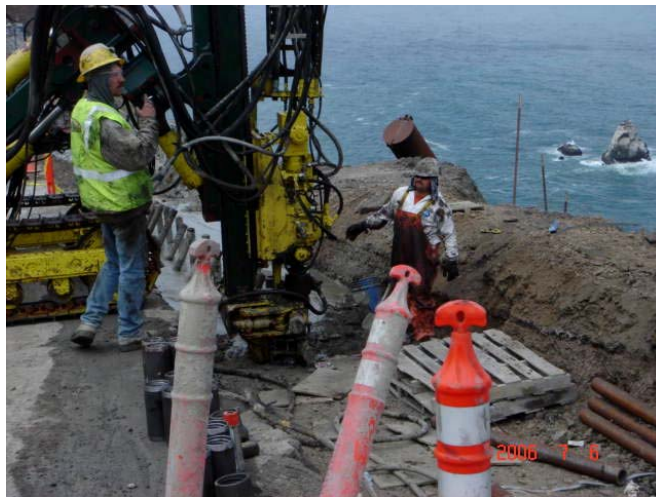
Micro pile wall drilling
